Preventative Maintenance Statement

Site~Rite Probe Alignment Test Procedure

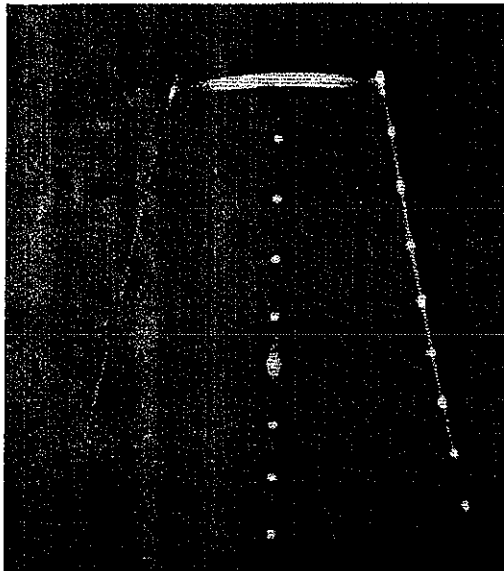
Figure 1 – Probe is Aligned.
The echo from the tip of the needle lines up with the depth markers.

1. Clip a pink (1.5 cm) 18 gauge needle guide onto the probe.
2. Insert an 18 gauge needle into the guide, bevel up.
3. Immerse the tip of the probe in a container of clear debubbled water (8 cm minimum depth).
4. Turn on the Scanner.
5. Turn on the depth markers.
6. Advance the needle, bevel up, until the tip appears as a bright dot.
7. Adjust the gain to optimize the image.
8. The depth markers should line up with the bright dot of the needle tip as in Figure 1.

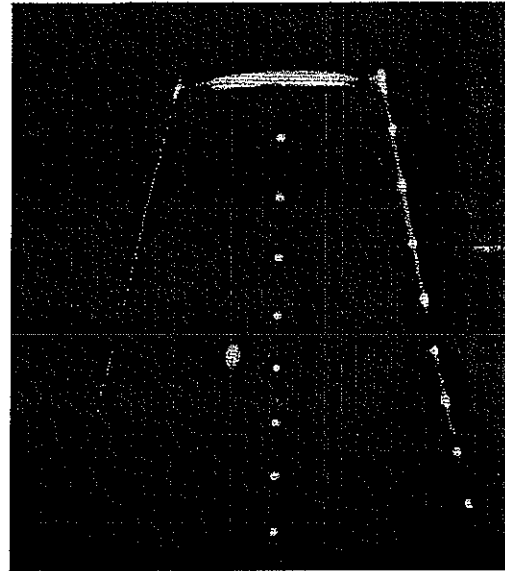
Figure 2 – Probe is Misaligned.
The echo from the tip of the needle does not line up with the depth markers.

Probes that are out of alignment must be returned to Dymax for repair.
